Virtual Rail Gaps

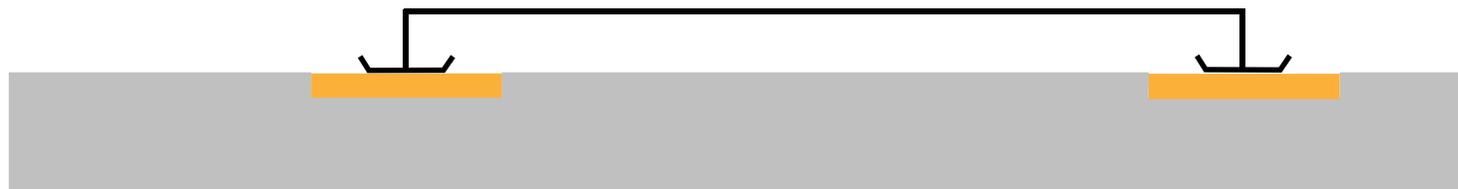
Two Virtual Rail Gaps on the negative rail - both shoes are off traction current

Virtual Rail Gap - an area of arcing on the Negative rail. It is usually non-conductive

On some sections of the negative rail, there are patches where arcing has occurred. They generally cover the width of the rail and are about 2 feet 6 inches long. For want of a better name, I will call these "Virtual Rail Gaps". Because the arcing has worn away some of the surface, these VRGs are mostly slightly below conductor rail level, or are non-conductive, meaning that most current shoes passing over the VRG will not pick up any current. There are often two of these VRGs together, or one VRG near a rail gap. The spacing of these VRGs or VRG and railgap, is such that when the two negative shoes on a car are passing over them, the car is "off juice".

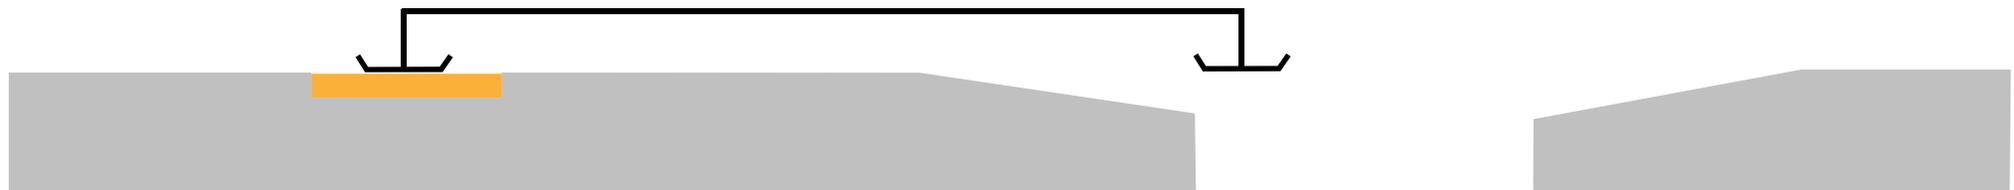
One Virtual Rail Gap and a rail gap on the negative rail - both shoes are off traction current

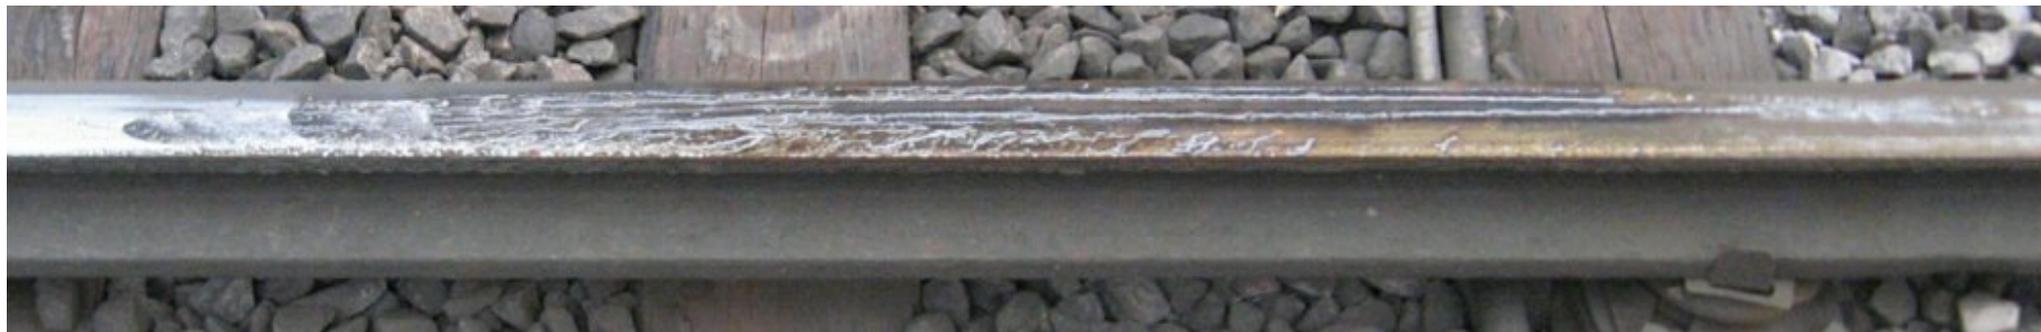
A VRG - arcing on the negative rail - most negative shoes will not pick up current when travelling over this.
